NUMBER 13: JULY 1957

The BBC Riverside Television Studios:

The Architectural Aspects

by E. A. FOWLER, L.R.I.B.A.

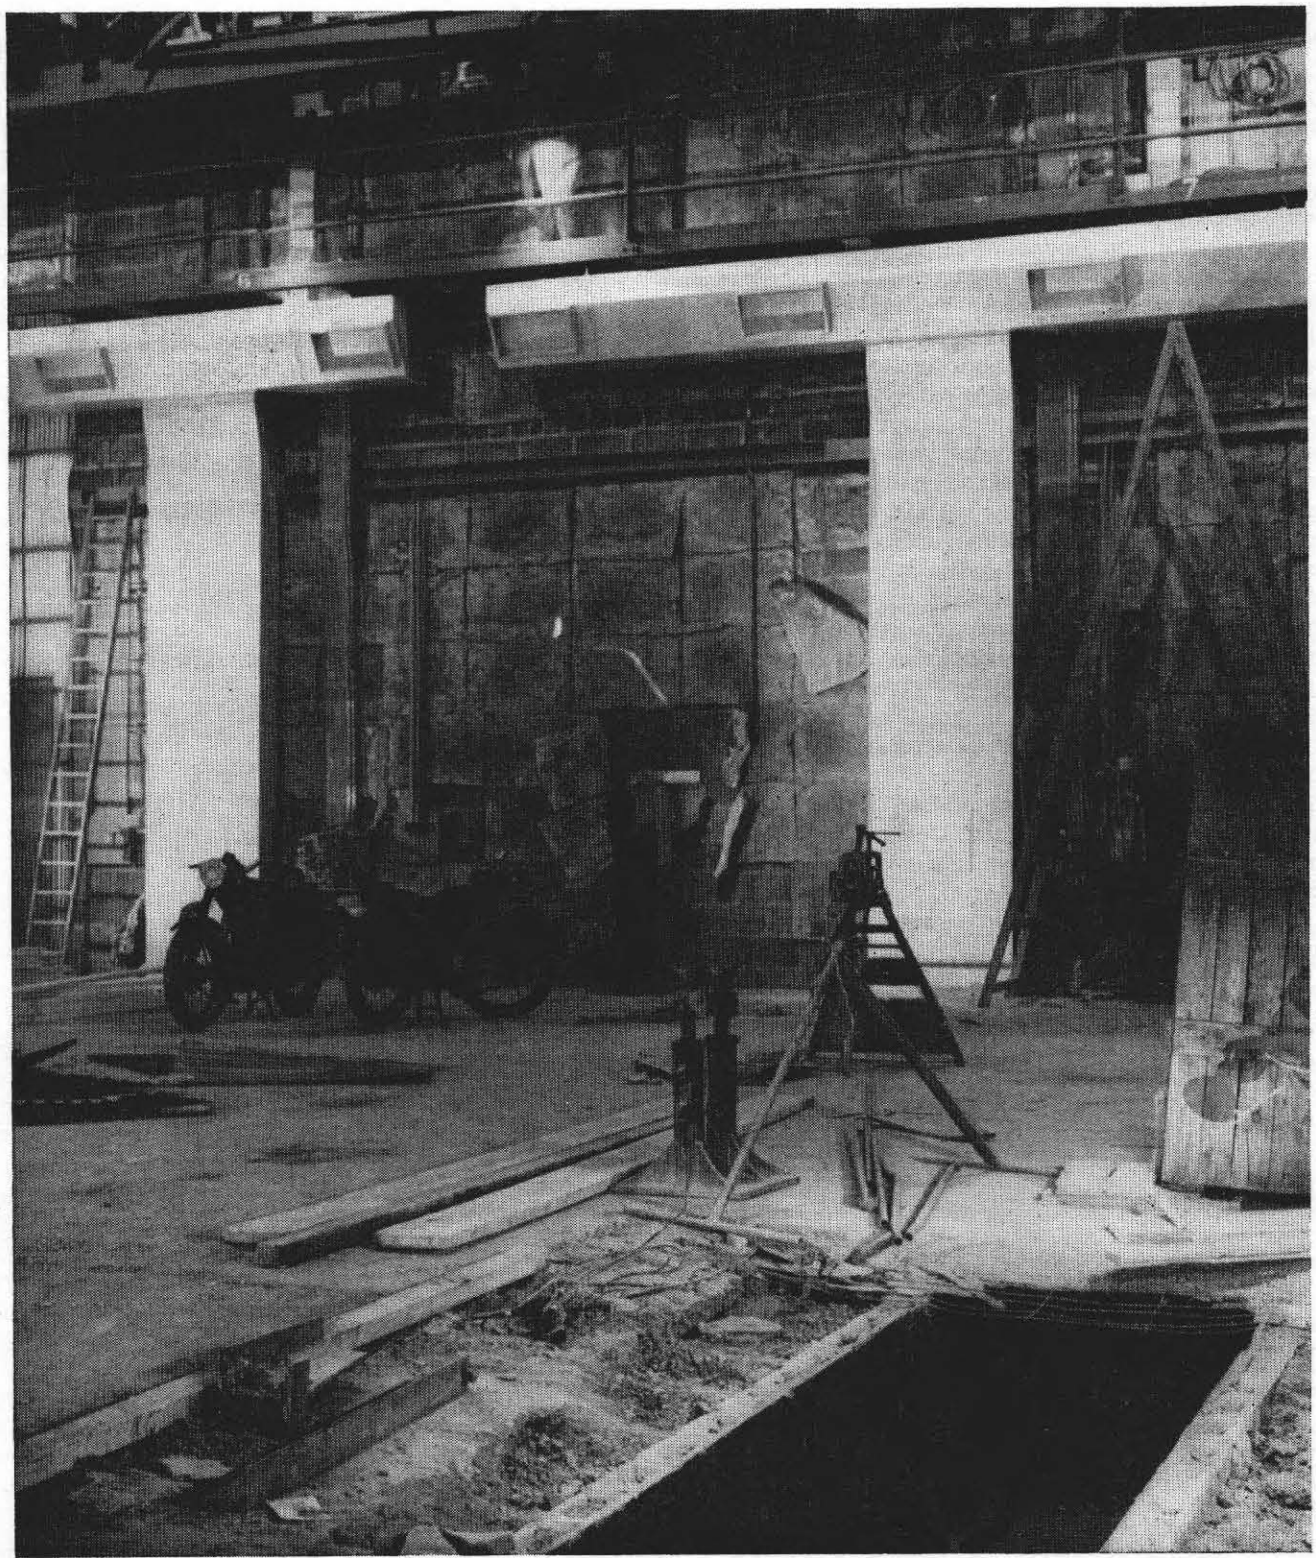
Plate A — Progress photograph showing underground vent ducts and vertical metal risers in Studio 1

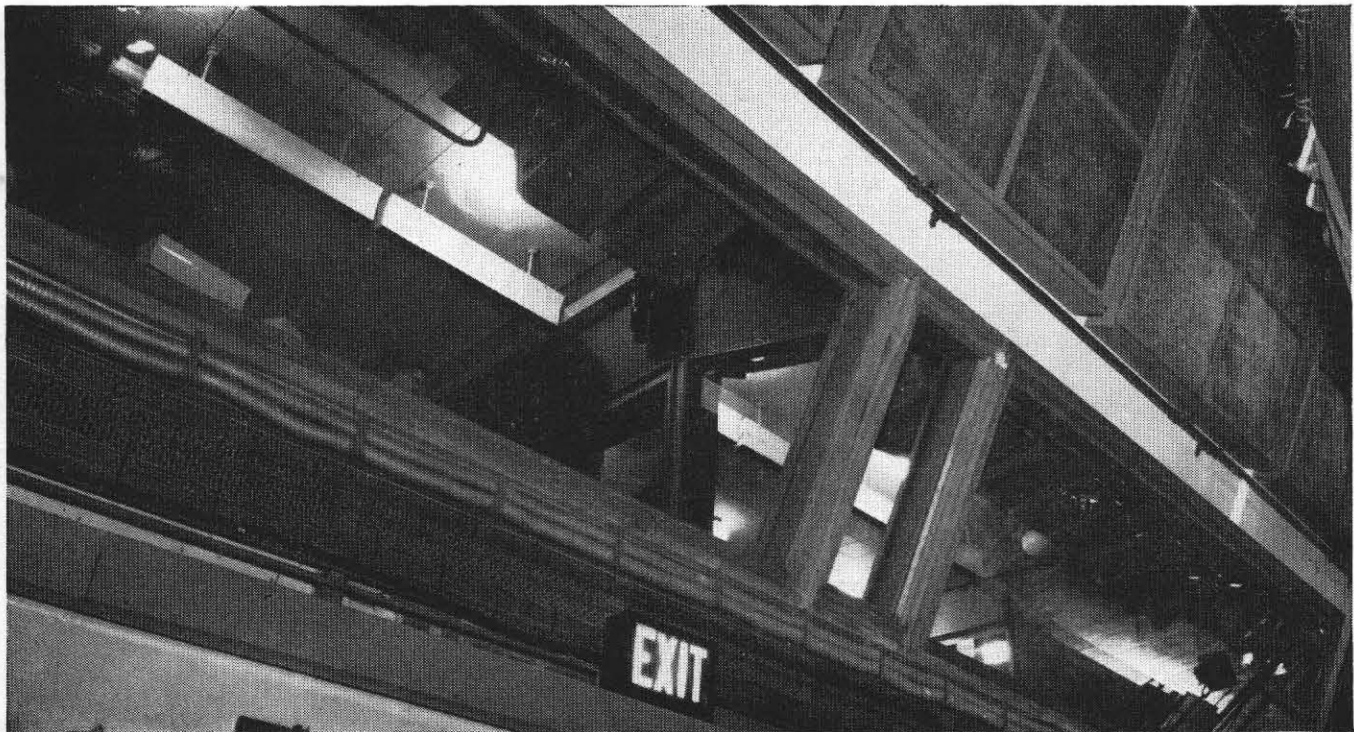
Plate E — View of Studio 1. Control suite windows from studio

the action on the studio floor and in the monitors simultaneously (see Plates E, F, and G). The equipment in these control areas was arranged to allow of 'front viewing' and power-operated windows were provided between the control rooms and apparatus room. The internal partition walling to the technical areas was formed with Camden partitioning. See Fig. 8 for detail.
